INDOOR AIR QUALITY ASSESSMENT

**City of Taunton
Board of Health Building
45 School Street
Taunton, Massachusetts**

Prepared by:
Massachusetts Department of Public Health
Bureau of Environmental Health Assessment
June, 2002

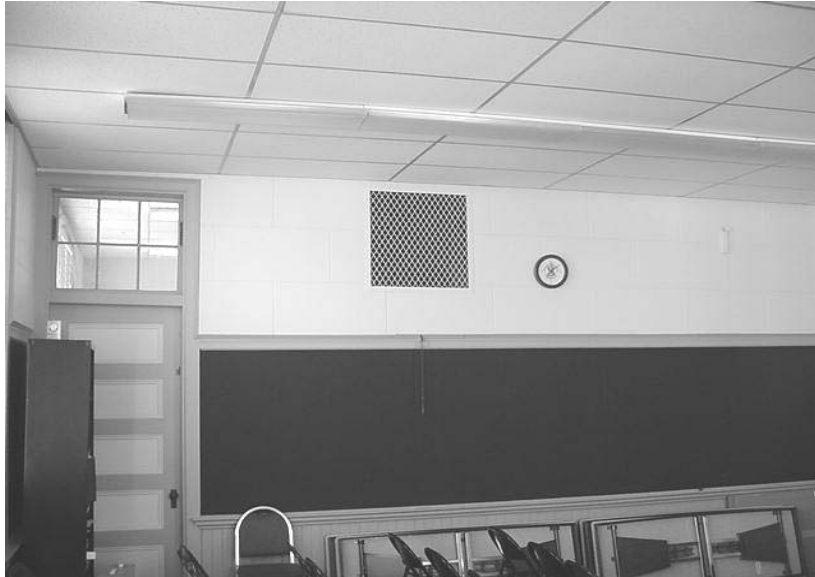
Picture 1

Ventilation was originally provided by a series of louvered vents that exist on both floors of the building. Each room has an approximately 3' x 3' grated air vent in the center of an interior wall near the ceiling, which is connected by an air shaft to one of two boilers in the

basement (see Picture 1). A corresponding vent (see Picture 2) exists in each original classroom near the doorways that is connected to an exhaust ventilation shaft that runs from the roof to the basement. These exhaust ventilation shafts are connected by basement chambers that exist on opposite ends of the basement. The building has two of these shafts on either side. Rooms were constructed around these shafts to provide exhaust ventilation. These ventilation shafts exist on either side of the building and terminate in a “hearth”-like opening in the basement.

With the installation of the air-conditioning system, vents on the first floor were sealed. Original vents still exist on the second floor, which are connected to the basement chambers. Since this system is now abandoned, the sole source of fresh air in the building during winter months is the use of openable windows. This system should be properly sealed to prevent drafts

and movement of dirt, dusts, molds and particulate matter migrating from the basement to the second floor offices. This would include sealing roof top stacks (where appropriate), room vents and basement passageways. With the lack of a fresh air supply or exhaust ventilation, pollutants that exist in the interior space will not be diluted or removed and can build up and remain inside the office.

Original Fresh Air Supply Vent in Meeting Room

1. Continue with plans to remove and discard odorous ceiling tiles. Install new ceiling tiles and monitor for odor presence.
2. Permanently seal openings on the second floor for the original ventilation system.

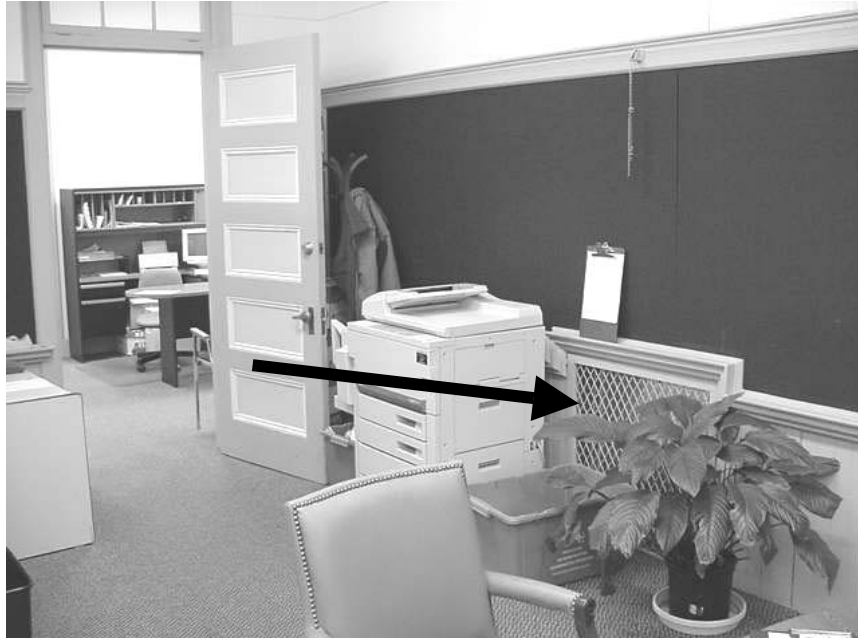
Picture 2

The floor level air vents provide exhaust ventilation. As the heating elements draw air into the hot air ducts, return air is drawn from the “hearths” at the bottom of the exhaust ventilation shafts. Negative pressure is created in these shafts, which in turn draw air into the floor vents of each original classroom. The draw of air into these cool air vents is controlled by a draw-chain pulley system. A percentage of return air rises up the ventilation shaft to exhaust outdoors.

Exhaust Vent in 2ND Floor Town Offices

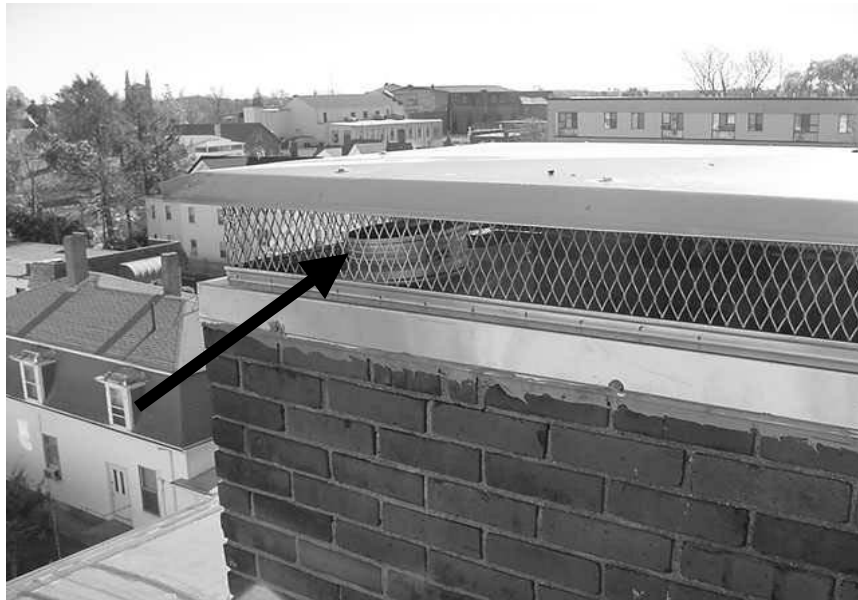
Picture 3

A new furnace was installed in the basement to replace the original furnace. A furnace vent was installed in the airshaft on the eastern side of the building. The terminus of this vent is installed beneath a rain cap that was installed over this airshaft (see Picture 3). In this configuration, furnace exhaust can build up under the rain cap and possibly re-enter the building by migrating down the eastern airshaft.

Furnace Vent Installed underneath Airshaft Rain Cap

4. Extend the furnace vent pipe through the chimney cap.
5. Continue with remediation steps to repair leaks moistening meeting room ceiling tiles.
6. For buildings in New England, periods of low relative humidity during the winter are often unavoidable. Therefore, scrupulous cleaning practices should be adopted to minimize common indoor air contaminants whose irritant effects can be enhanced when the relative humidity is low. Drinking water during the day can help ease some symptoms associated with a dry environment (throat and sinus irritations). Consider

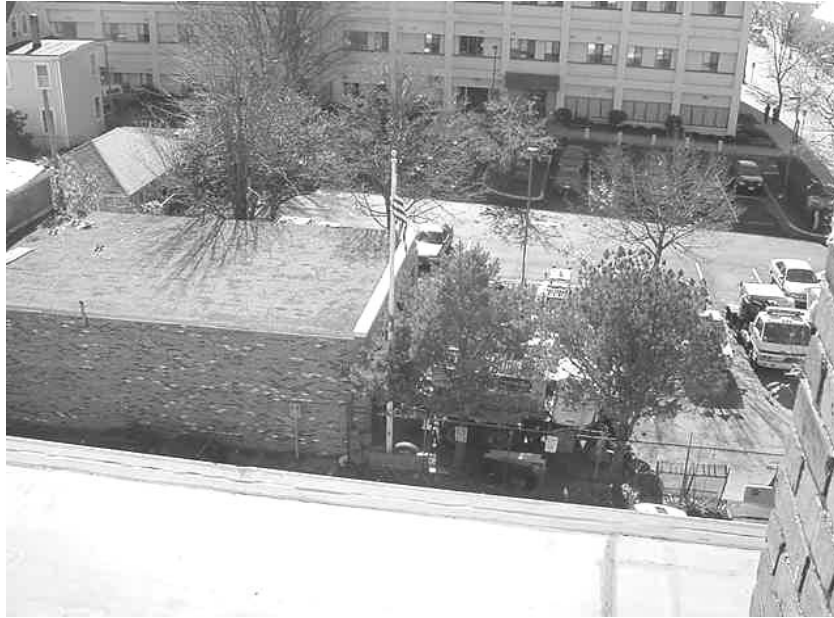
Picture 4

An odor of acetone was reported by building occupants. During the assessment, the odor of acetone was detected on the roof. Immediately adjacent to the BOH building is a shop that conducts motor vehicle bodywork and spray painting (see Picture 4). The shop was directly

upwind during the assessment, which may indicate that this establishment is the source of the acetone-odor inside the building. The pathway for this odor may be entrainment by the airshaft on the west side of the building, particularly during cold weather early in the morning as cold air sinks down the airshaft.

Vehicle Maintenance Garage Believed To Be Source of Acetone Odor

3. Since neither airshaft on the roof serves their original purpose as exhaust vents, consideration should be given to sealing these vents at the roof level, as well as in the basement. Sealing the airshafts may prevent paint odors from the shop from penetrating into the building.
